At Sea Test 2 Recovery Cruise Cruise 206 On Board R/V *Knorr* April 10 – 15, 2012 Woods Hole – Woods Hole, MA

Technical Report

WHOI Technical Report 2012-07
CGSN Document 3207-00034
Coastal and Global Scale Nodes
Ocean Observatories Initiative
Woods Hole Oceanographic Institution
Woods Hole, Massachusetts 02543

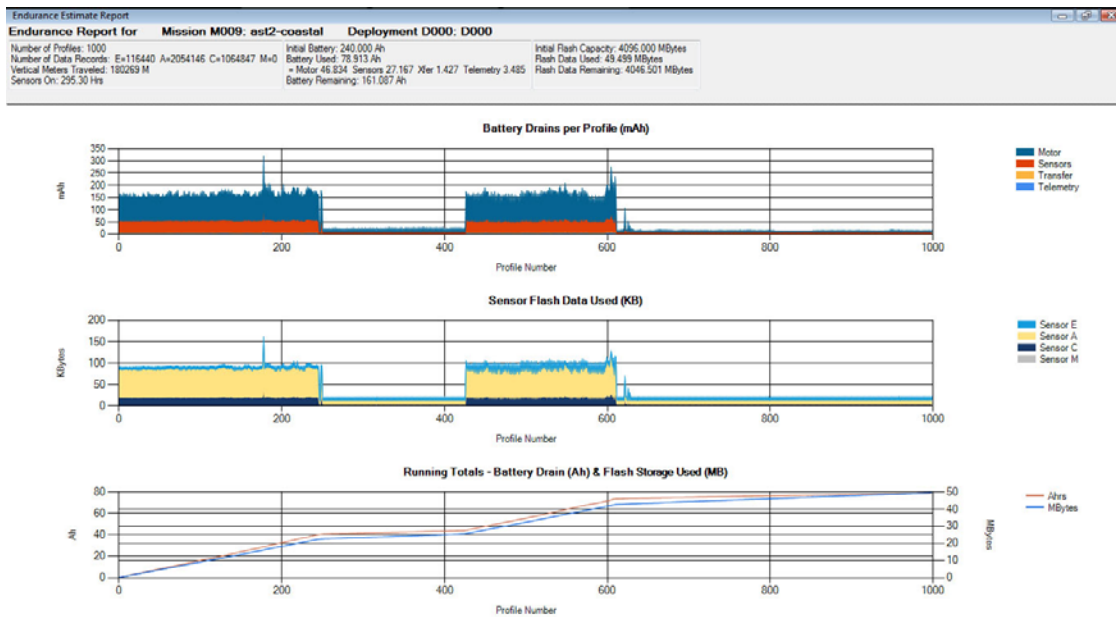
Figure 9: Mission Planner output from the CPM WFP.

Output from the CPM WFP Mission Planner (Figure 9) and selected data (Figure 10) indicate that the system functioned as expected throughout much of the deployment.

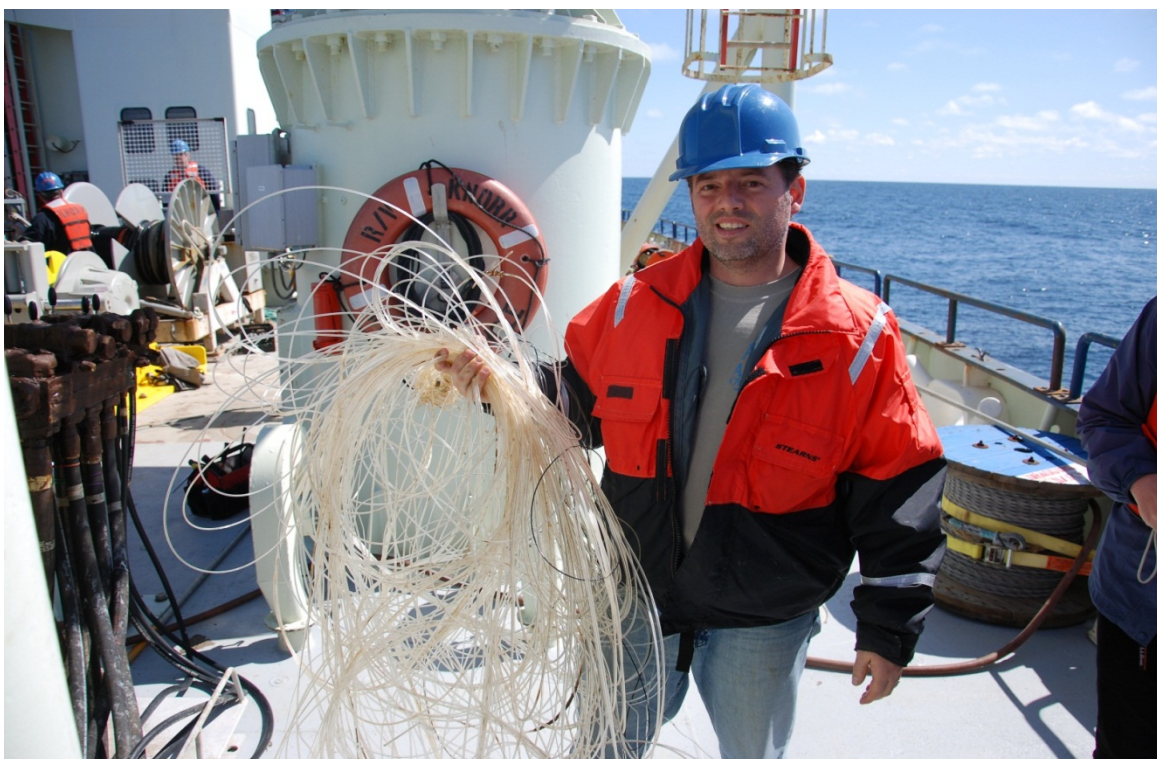
- Research Vessel Connecticut is a good resource for inspections and repair operations requiring modest capability.
- Fishing operations (both drifting and active) are extensive at the Pioneer Array site (Figures 12 and 13).

Figure 13: Fishing line recovered from AST2 mooring.

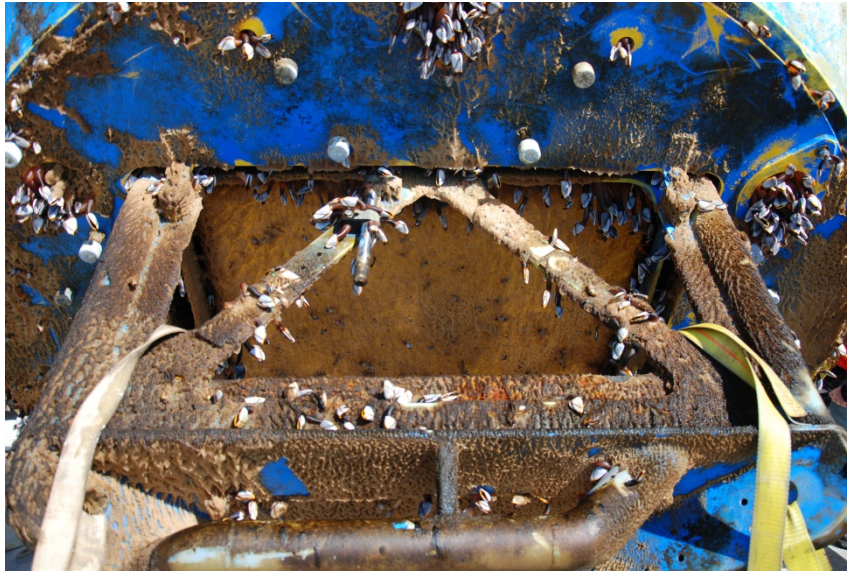
- Biofouling was heavy (Figure 14).
- Deformation occurred on some hose terminations (Figure 15) caused by pressure at depth.
- Castors on deck carts (Figure 16) should be replaced by fixed tracks.

Figure 14: Example of biofouling,.

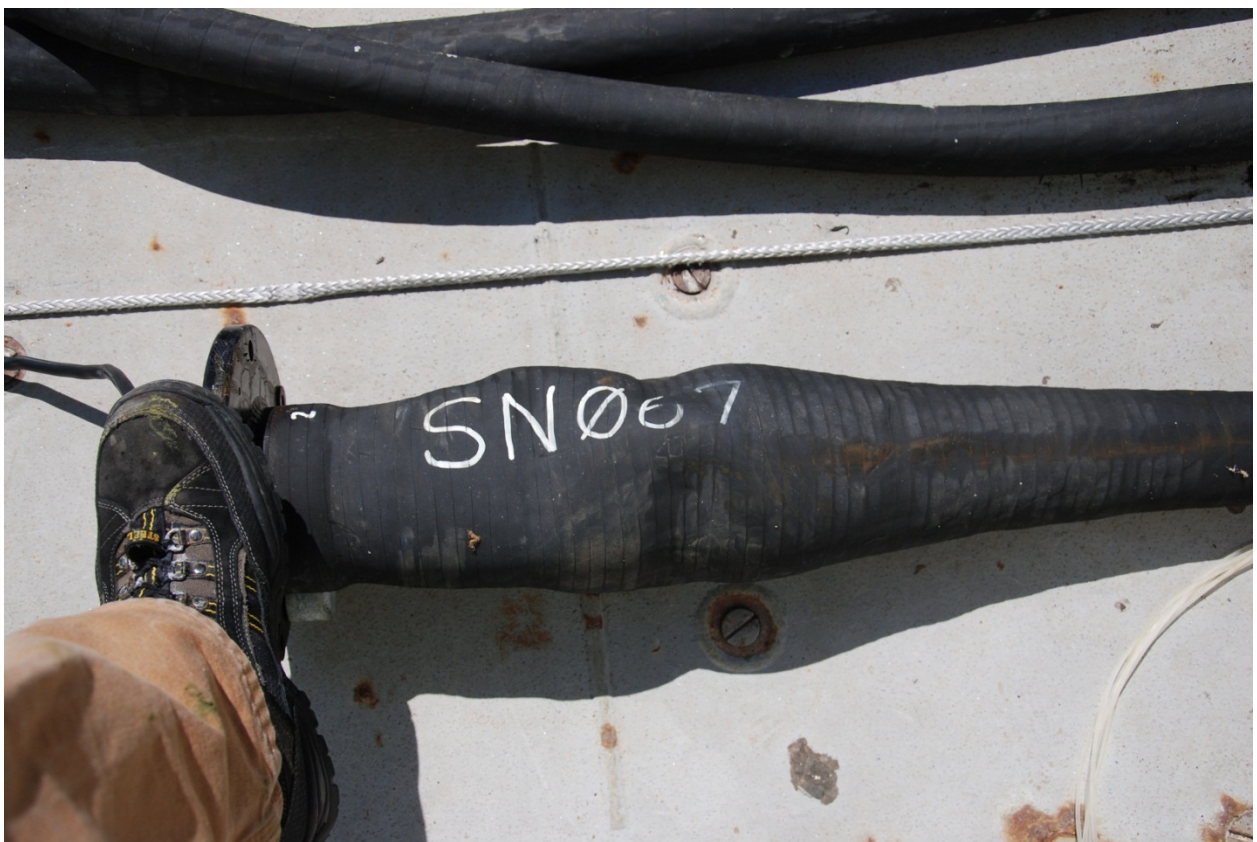
Figure 15: Deformation of hose termination caused by pressure.

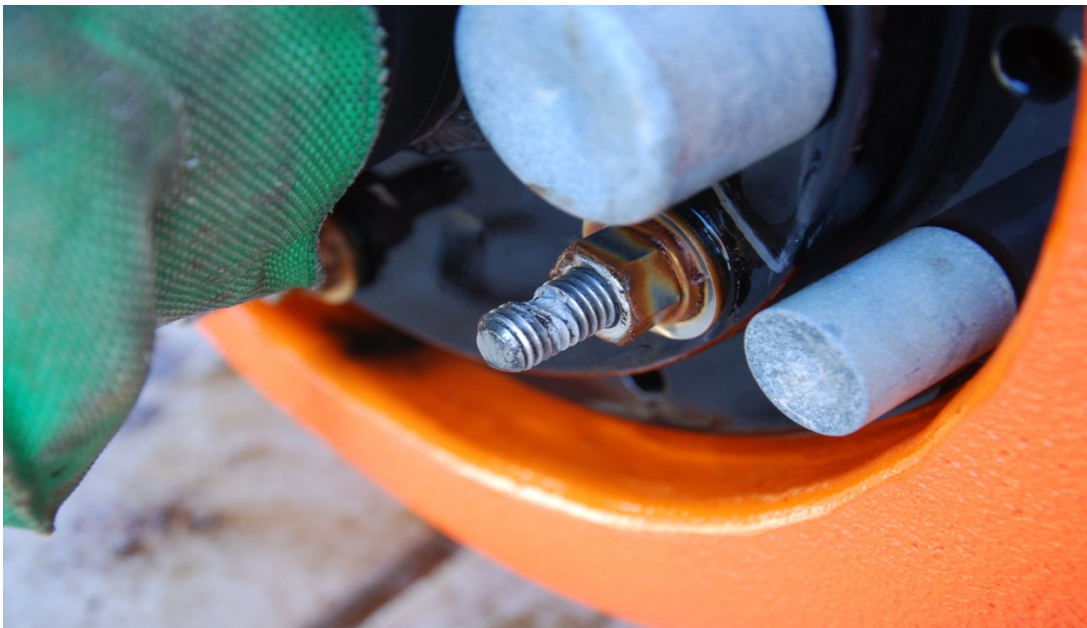
- Corrosion occurred on some mechanical connections (Figure 17) and should be better protected with anodes or changed to titanium.

Figure 17: Example of corrosion of a bolt on an end cap.

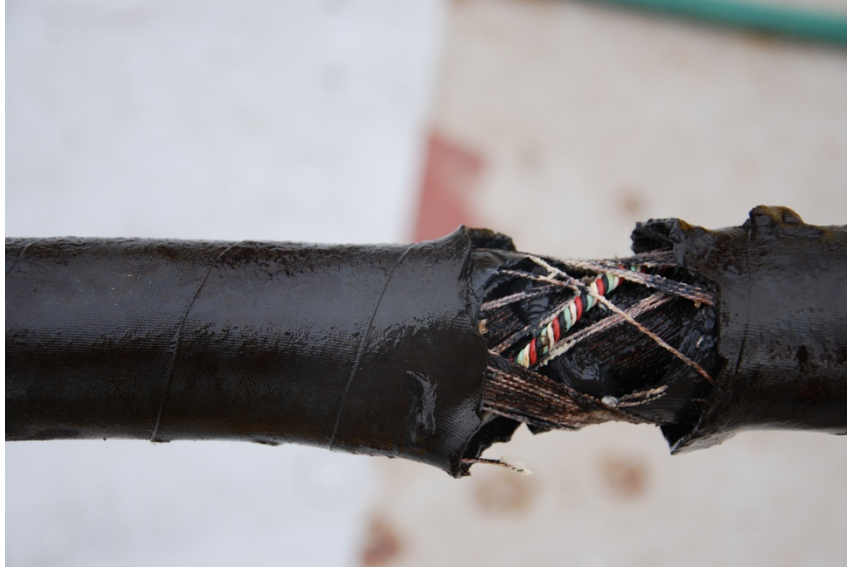
Examination of the CPM after recovery indicated a broken Kevlar member (Figure 18) in the stretch hose and a nick in a jacketed wire (Figure 19), which did not cause problems with inductive communications. The release system should be modified so that the mooring and anchor can be recovered separately.

Figure 18: Photo of broken Kevlar member on AST2 CPM.

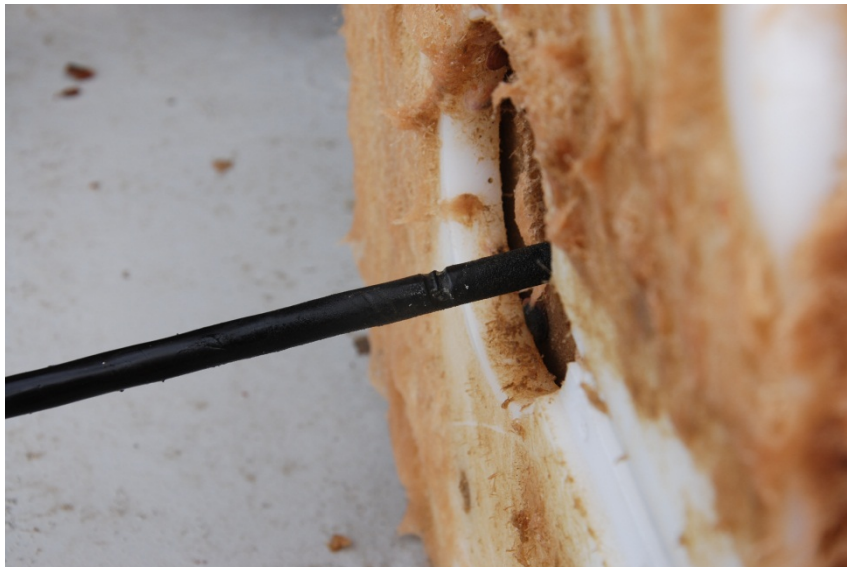
Figure 19: Photo of nick in jacketed wire on AST2 CPM.

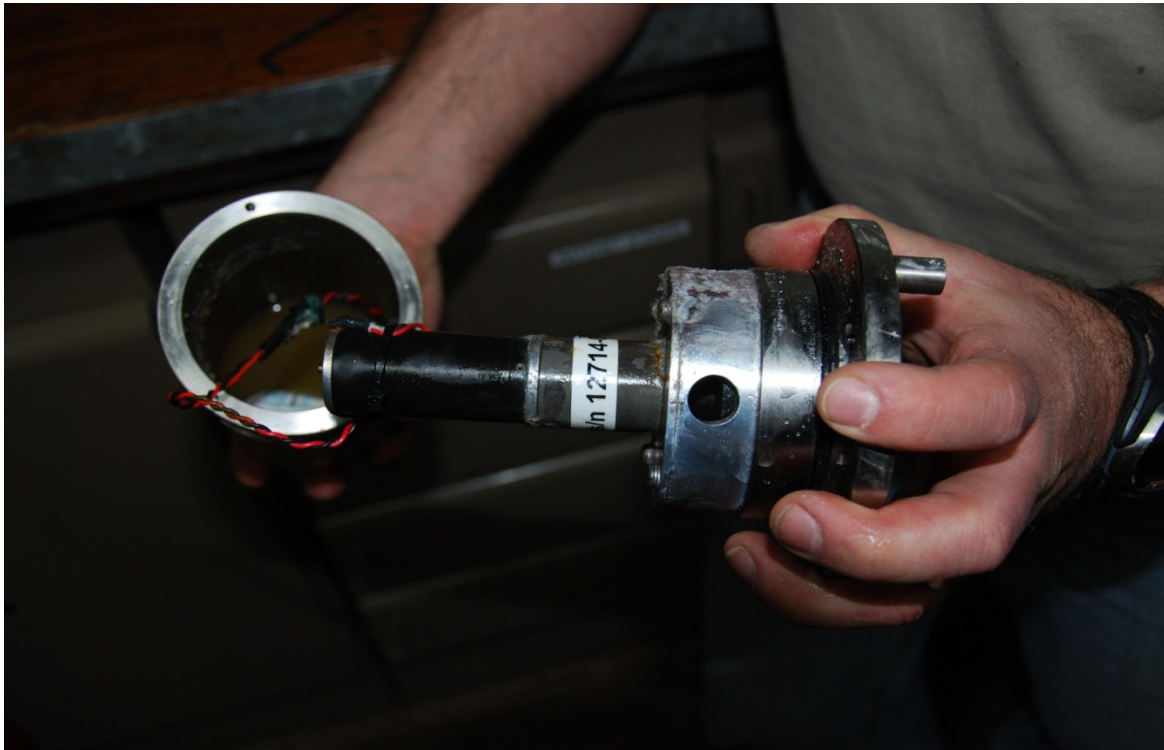
movement. At 1210 EDT the operator plugged a laptop into the WFP serial port, canceled the deployment, went to the bench-test menu and ran a motor test. There was no movement and the motor appeared to have braked or seized. A brake release command was sent but the motor remained stuck. The skin was pulled off the motor connector, which was rusty on one side. The motor housing was removed from the WFP, and the motor housing connector was bubbling and leaking water. The end cap bolts were turned ½ turn, and the end cap was under pressure. Further action was delayed to let the pressure dissipate. On April 13 at 1800 EDT the end cap was removed. The housing was full of water and there was corrosion (Figure 20), including a fully corroded capacitor. It was clear that a failed Impulse connector caused the flood. The Impulse connector mounted in the end cap might have been over-torqued prior to deployment, separating the neoprene jacket from the stainless steel body.

Figure 20: Corrosion on CPM WFP unit.

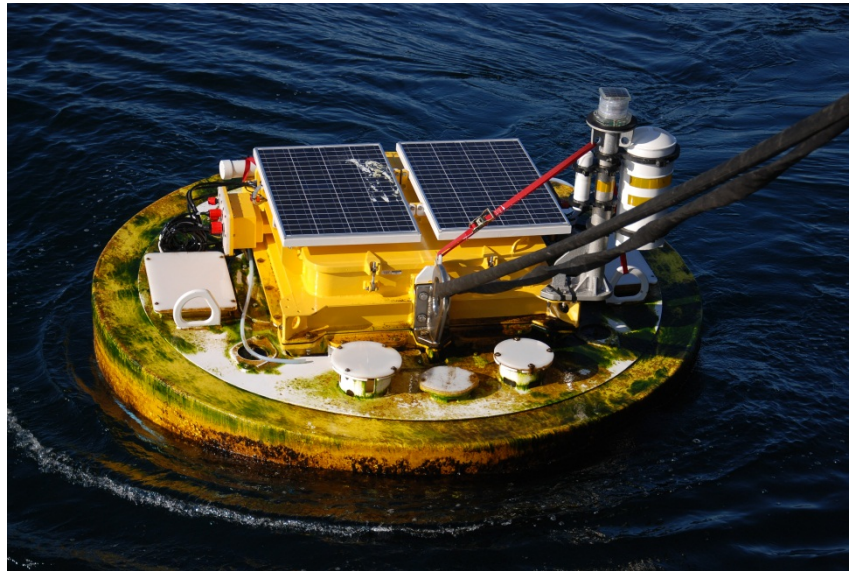
The mast on the surface buoy broke off during the at-sea period and required a temporary tower with a light to be attached. The surface buoy had only about 10 inches of freeboard (Figure 21) making it wet enough to support biofouling growth. A fouled wet surface makes the deck slippery and difficult to work on at sea. The BARF surfaced upside down (Figure 22). The release system should be modified so that the mooring and BARF can be recovered separately.

Figure 21: Photo of surface buoy on AST2 CSM just prior to recovery, showing absence of the mast and small freeboard. Note the deck is biofouled and slippery due to the low freeboard.

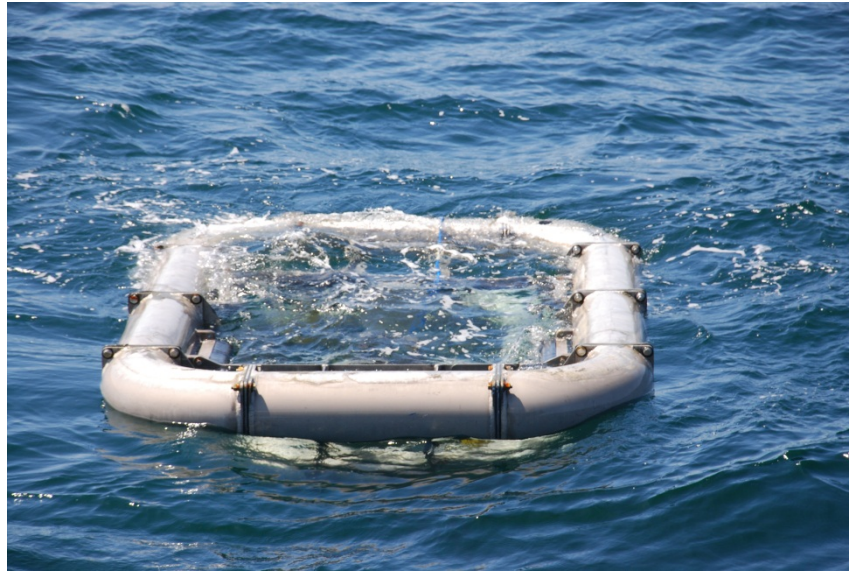
Figure 22: Photo of BARF surfacing upside-down during recovery.
